MINJAR GOLD

Rehabilitation Review of Waste Landforms at Southern Cross Operations

Vanja Sekizovic
Environmental Superintendent
Tianye SXO Gold Mining Pty Ltd

7 September 2018

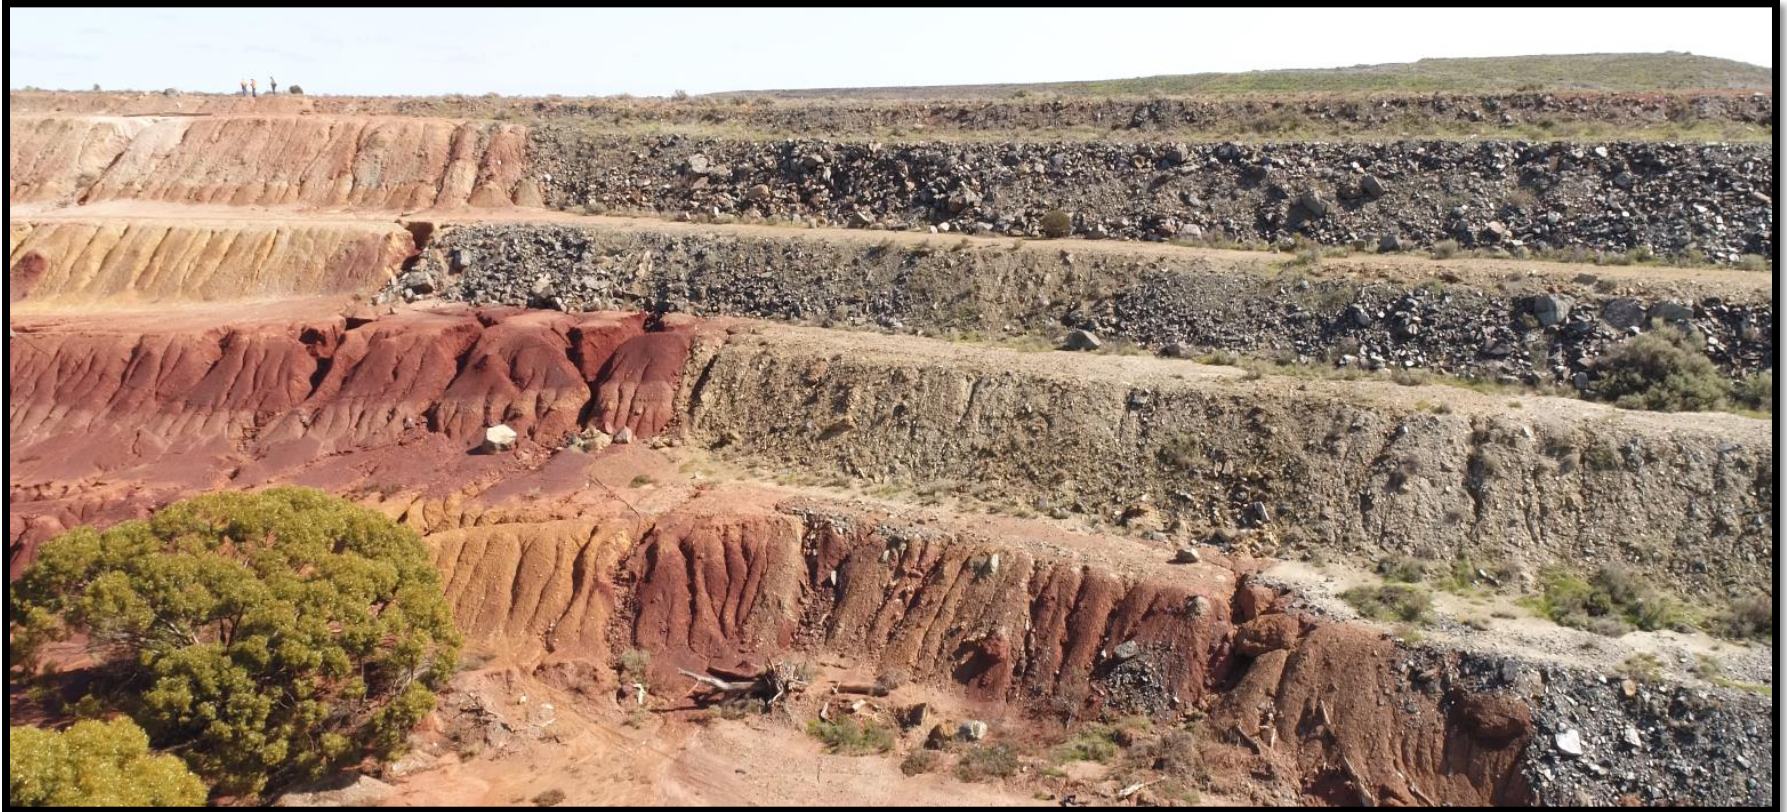
Frasers South WRD

- Berm and bench slope, steep
 - No ripping
 - No topsoil
 - No seeding
 - Not armored with competent rock
-
- Accepted by Department of Minerals and Energy (DME now DMIRS) in 1998 (relinquished)

Fraser	• Characterised by old style rehabilitation requirements. Accept as is. However, any future mining will be required to follow current DME standards.
--------	--
