# Nevoria Mine

# Nevoria South WRD

# Hercules Mine

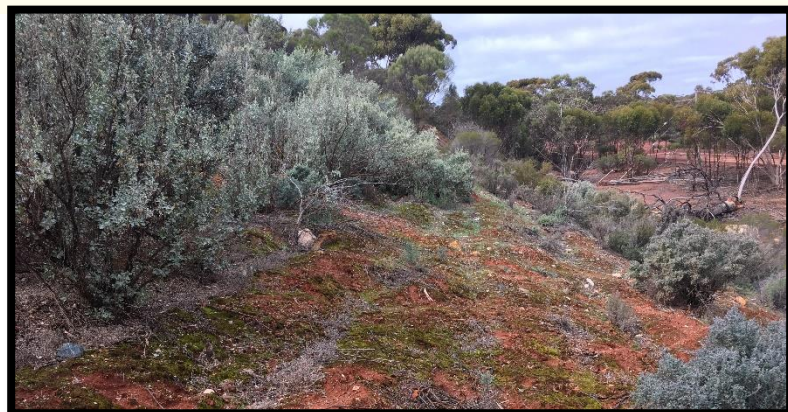
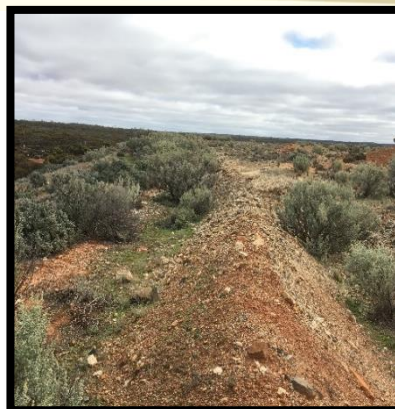
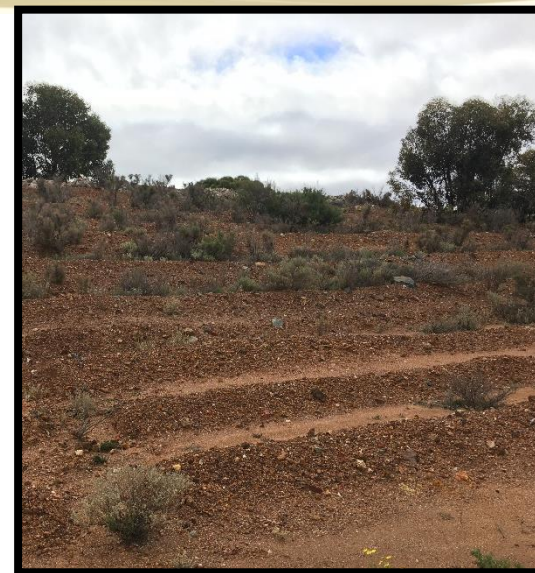
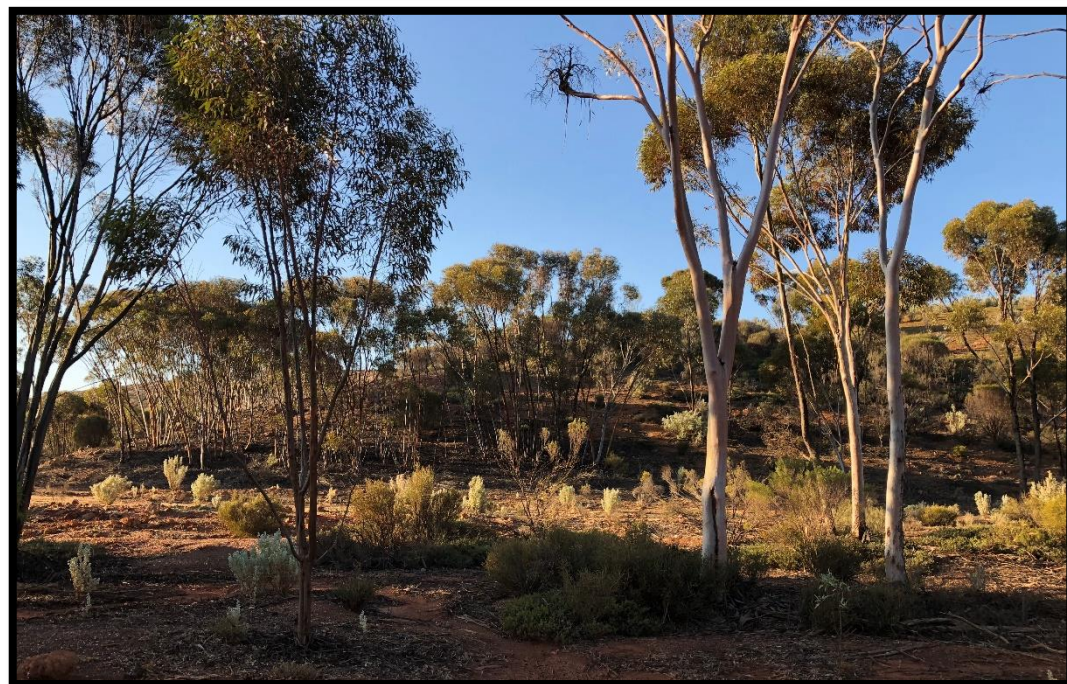
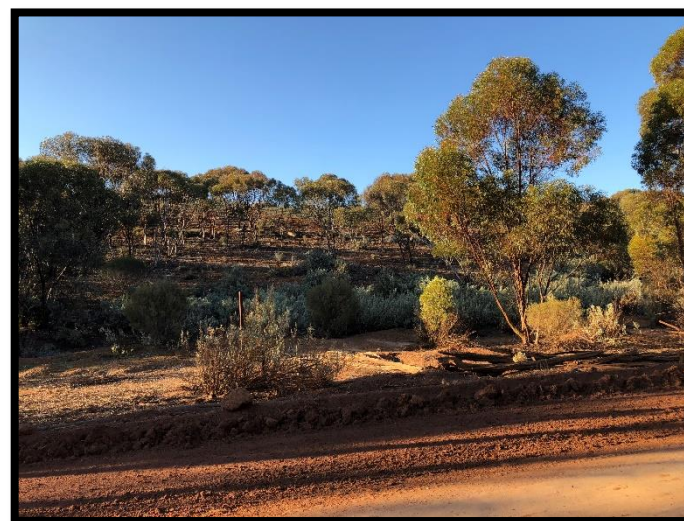
# Nevoria South WRD

- Variety of rehabilitation methods:
    - Bench & berm;
    - Contour ripped; and
    - Convex.
  - Topsoil depth and profile varies
  - Sporadic seeding
  - Erosion evident in bench & berm area, not where it has been contour ripped
- 
- Accepted in part by Department of Minerals and Energy (DME now DMIRS) in 1998 (relinquished)
