# Nevoria Mine

# Nevoria South WRD

# Hercules Mine

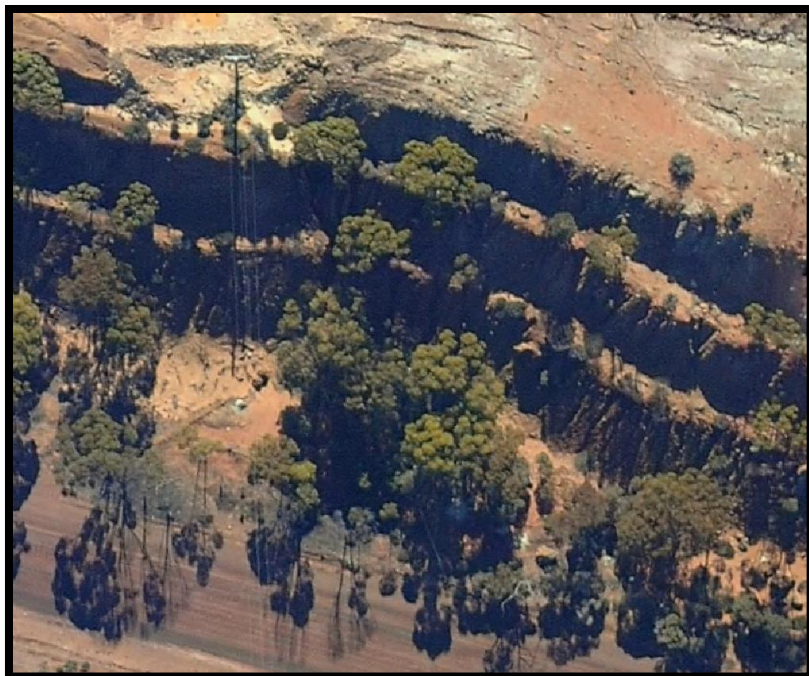
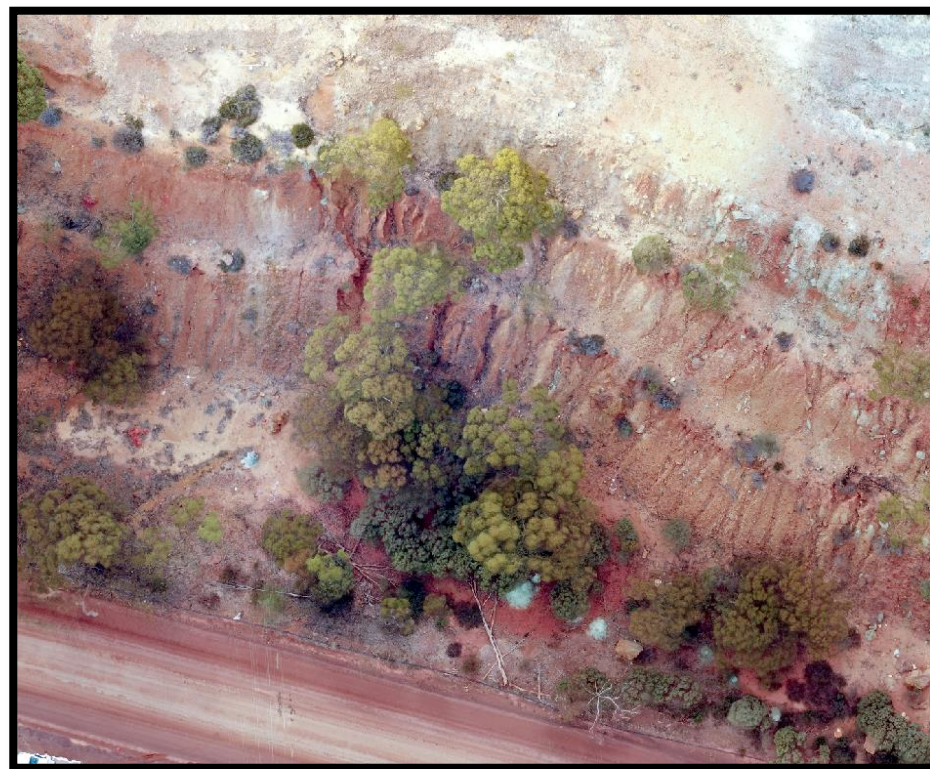
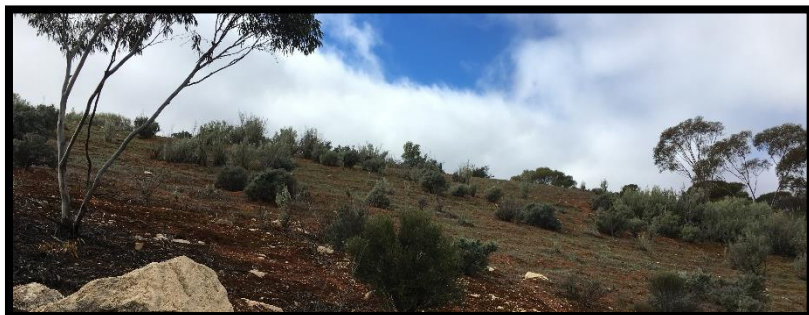
- Headframe and shaft mining between 1906 to 1963
- Open pit mining in 1980s and 1990s
- Underground mining in 2000s
- Nevoria South Waste Rock Dump:
  - Constructed 1990s
  - Rehab 1997 & 2007
  - No berms
  - Total height 30m
  - 2,553,000m<sup>3</sup> volume; ~24ha
  - 20°; 37° & 70° batter slopes
  - Water shedding criteria for water management
  - Minimal environmental design
  - Seeding on western face
  - Waste rock mineralogy: Weathered basalt with clay alteration

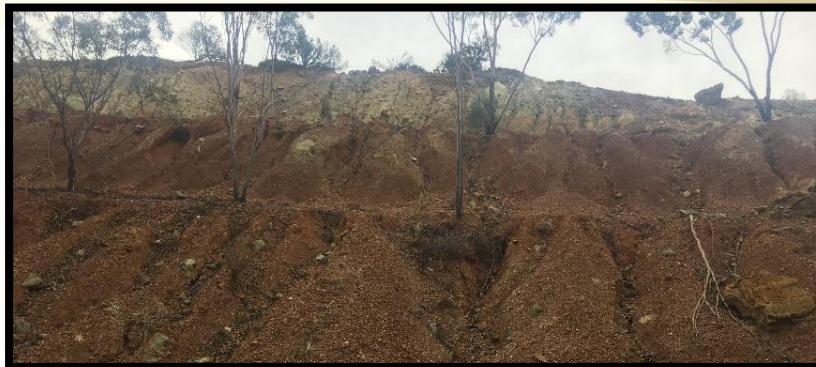
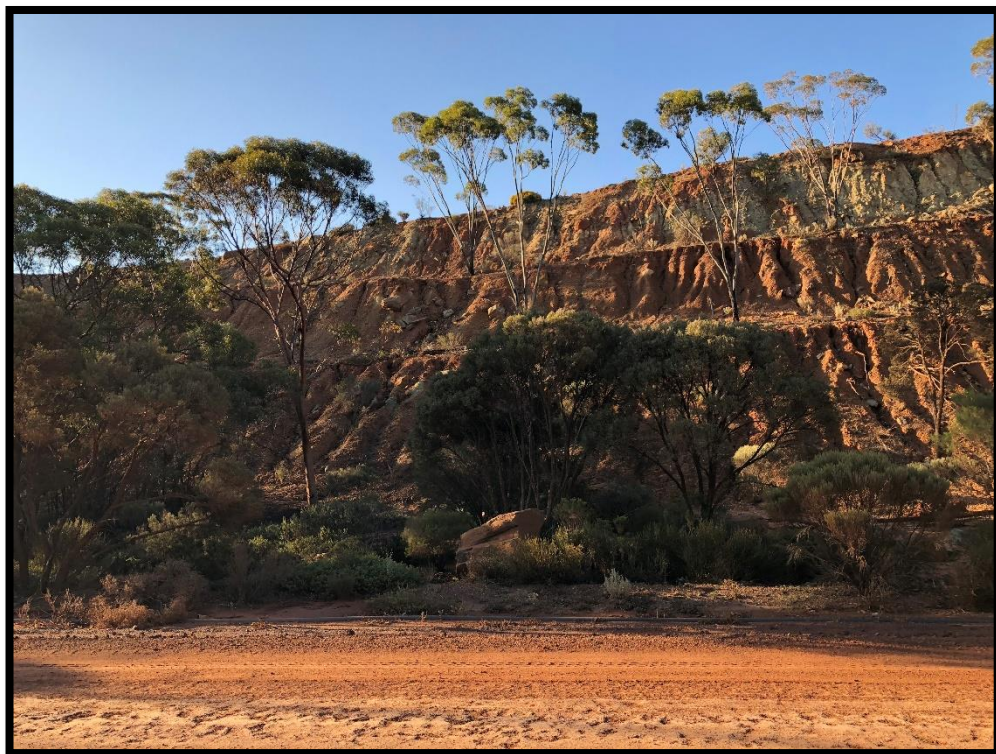
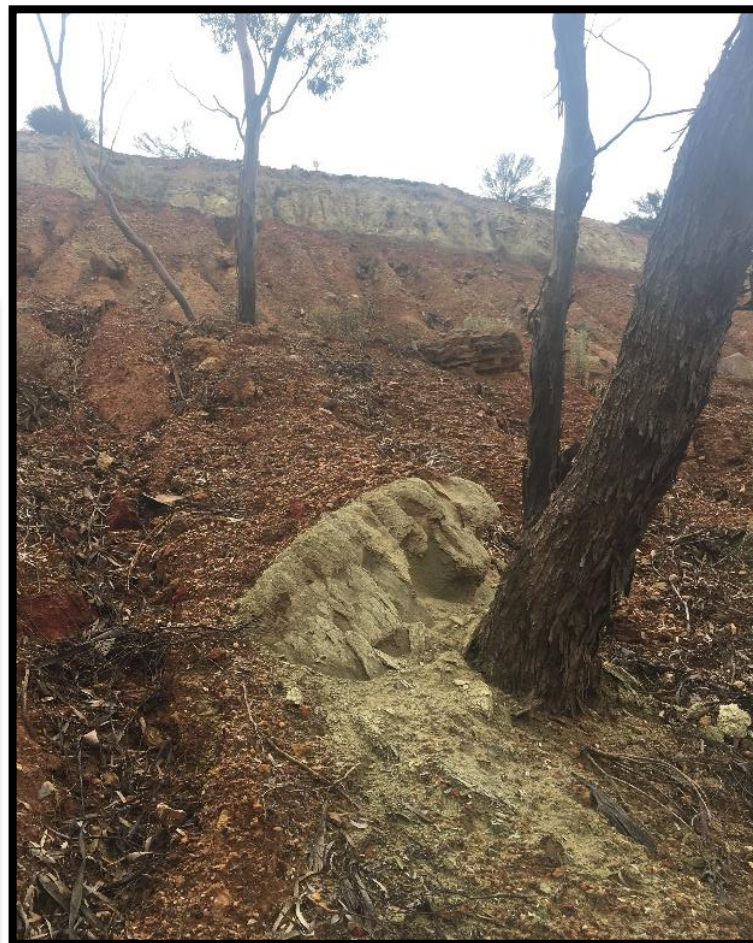
- Variety of rehabilitation methods:
    - Bench & berm;
    - Contour ripped; and
    - Convex.
  - Topsoil depth and profile varies
  - Sporadic seeding
  - Erosion evident in bench & berm area, not where it has been contour ripped
- 
- Accepted in part by Department of Minerals and Energy (DME now DMIRS) in 1998 (relinquished)

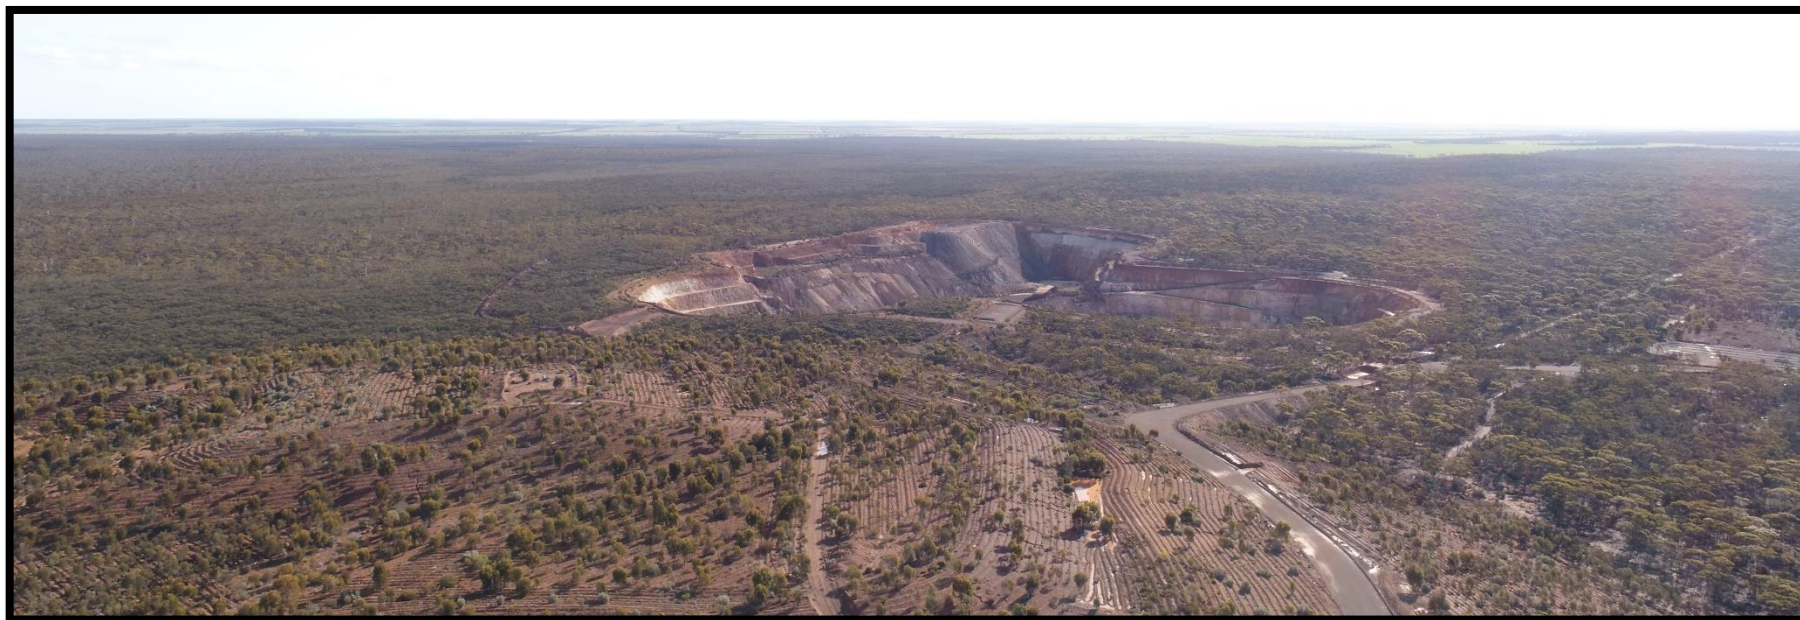
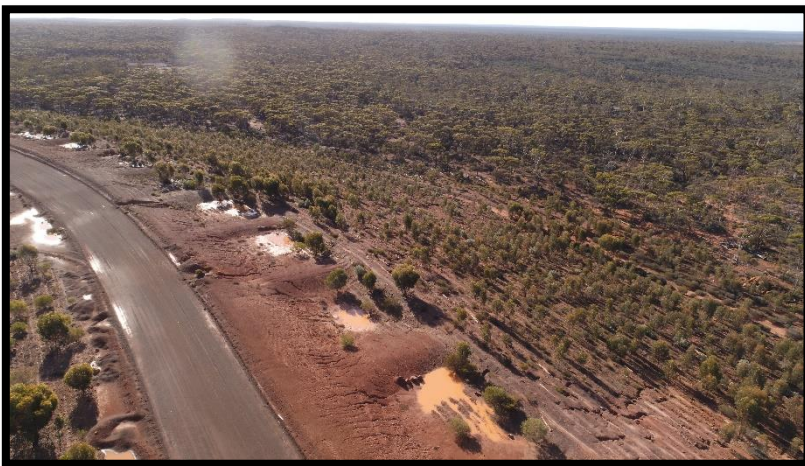
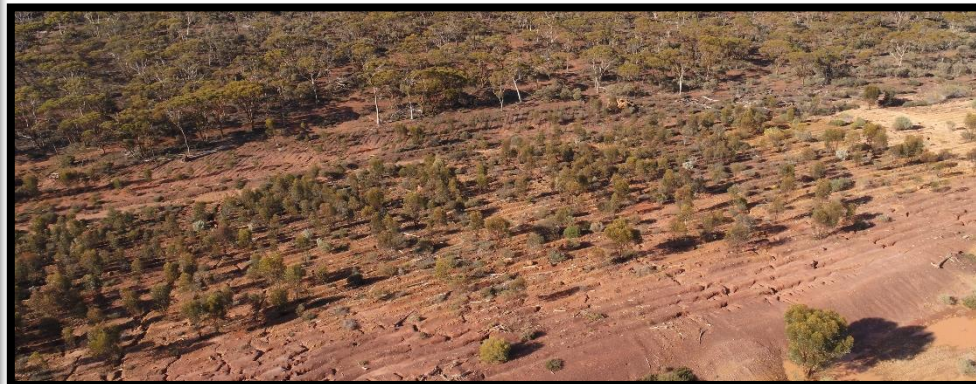
- Burbidge area mined in 1890s
- Great Victoria Gold Mine (GVG) mined in 1990s and 2000s
- Hercules mined 2005 to 2007
- Hercules Waste Rock Landform
  - Constructed 2005 to 2007, over existing Tailings Storage Facility (TSF)
  - Total height 29m
  - 4,998,415m<sup>3</sup> volume; ~62ha
  - 15° to 18° batter slopes
  - Store and lease design criteria for water management
  - Top of landform is undulating and celled
  - Seeded
  - Waste rock mineralogy: Meta – sediments, gossan, ultramafic, encapsulated pyrite sediments
